Pre-Purchase Visual Property Review

Sample Report | Owner-Side Property Advisory in Mallorca

PROPERTY ADDRESS	[Address in Palma de Mallorca]
PROPERTY TYPE	Townhouse
CLIENT	[Client / Law Firm]
DATE OF VISIT	11 May 2026
WEATHER CONDITIONS	Sunny / Dry
PREPARED BY	Julien Michau - Property Advisor & Project Manager
REPORT STATUS	Sample report - for demonstration purposes

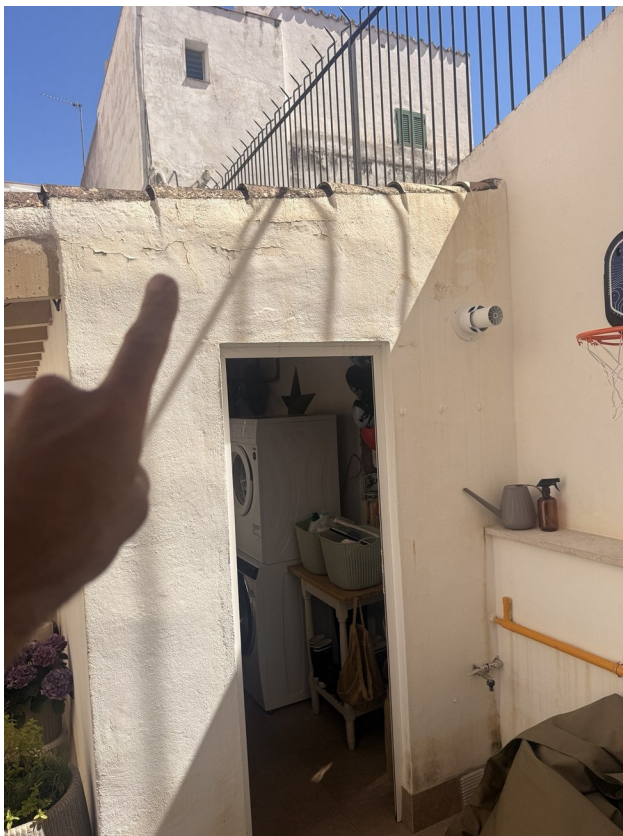
OBS-01 - Exterior utility room render cracking and surface deterioration

Priority: Medium - preventive maintenance

Visible observation: Minor exterior cracking and surface deterioration are visible on the render above the utility room opening. The area is exposed to sun, rain and thermal movement.

Potential impact: If left untreated, cracks and weakened render can allow water penetration, progressive surface degradation and staining around the opening.

Recommended action: Scrape loose material, repair cracks and render, apply exterior-grade coating and verify that water does not accumulate at the roof edge above.

Indicative cost: Approx. 350-650 EUR depending on surface preparation and repainting area.

Specialist / trade: General contractor / exterior render specialist.

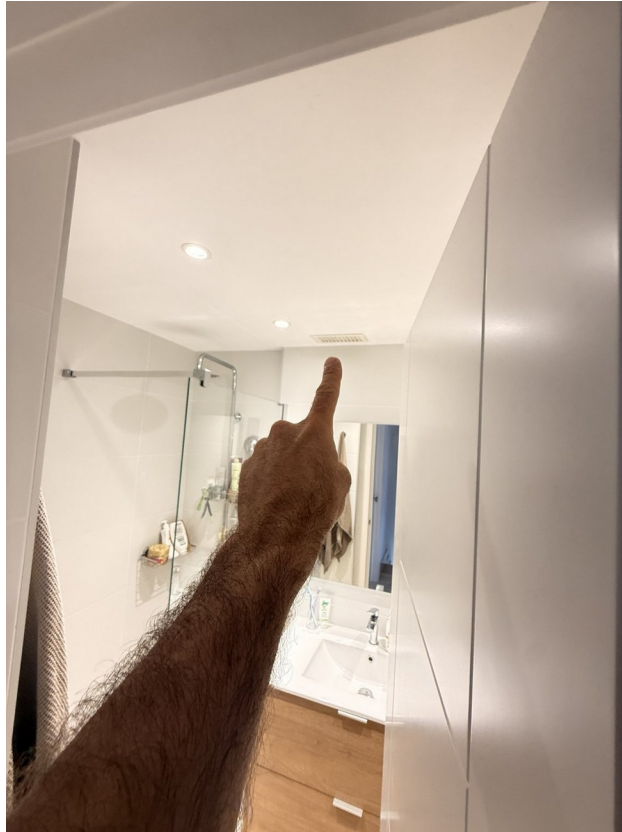
OBS-02 - Bathroom without adequate mechanical ventilation

Priority: Medium - comfort and moisture prevention

Visible observation: The bathroom appears to have no natural window and no clearly adequate mechanical extraction to the exterior.

Potential impact: Poor ventilation increases condensation risk, can create mold, accelerate deterioration of finishes and cause odors in enclosed bathrooms.

Recommended action: Install a mechanical extractor with appropriate ducting to the exterior where feasible. Confirm electrical connection and building constraints.

Indicative cost: Approx. 450-700 EUR depending on duct route and access.

Specialist / trade: Electrician / ventilation technician.

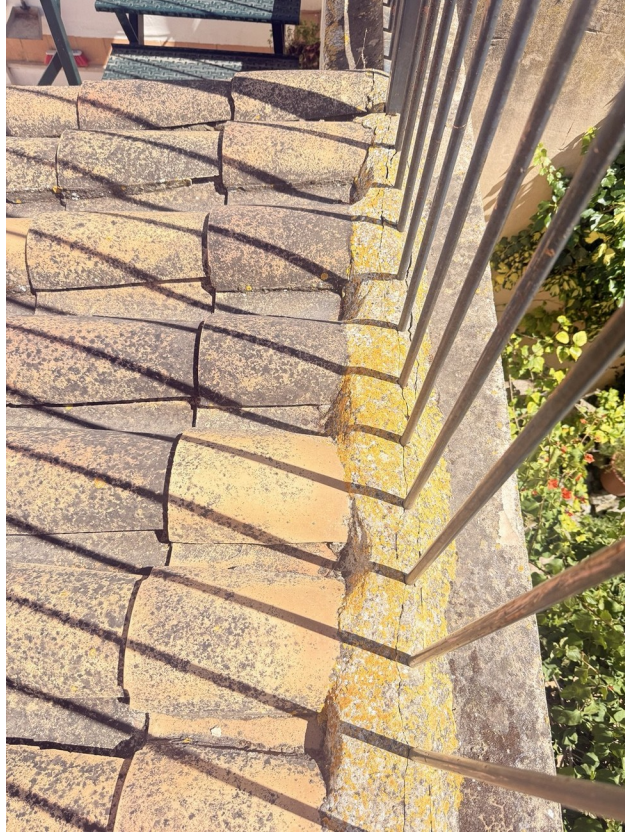
OBS-03 - Roof edge / flashing mortar requiring prompt repair

Priority: High - water ingress prevention

Visible observation: The accessible roof edge and mortar/flashing zone show visible ageing and localized cracking around the roof tiles and perimeter detail. The main residence roof itself was not accessed because access is through the neighbouring property and the neighbour was absent during the visit. No moisture marks were observed on the upper-floor ceilings at the time of inspection.

Potential impact: This is a priority maintenance point. Open joints or cracked mortar at roof edges can become a water entry path during heavy rain or wind-driven rain.

Recommended action: Have a roofer review the accessible roof edge, renew cracked mortar/flashing details, seal vulnerable points and arrange access to the main residence roof for a complete roof check if the buyer wants stronger comfort before purchase.

Indicative cost: Approx. 800-1,400 EUR for localized repair; more if broader roof works are required.

Specialist / trade: Roofer / waterproofing contractor.

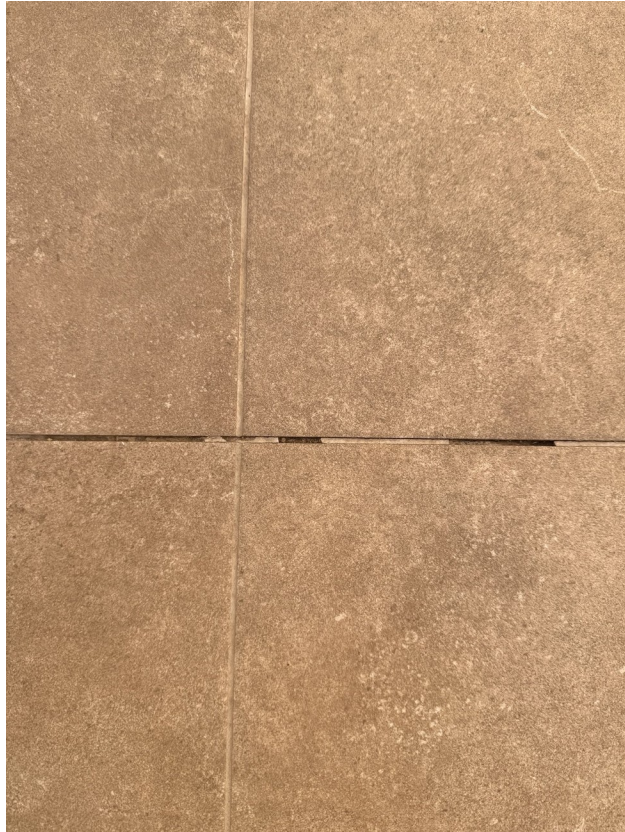
OBS-04 - Terrace tile grout joints to review

Priority: Medium - water management and maintenance

Visible observation: Open or deteriorated joints are visible between terrace floor tiles.

Potential impact: Open joints can allow water to penetrate below the tile surface, potentially causing staining, tile movement, substrate deterioration or infiltration in adjacent areas.

Recommended action: Clean and regrout defective joints. Where the terrace is above enclosed space or sensitive areas, verify waterproofing condition.

Indicative cost: Approx. 250-600 EUR for localized regrouting; more if waterproofing repairs are required.

Specialist / trade: Tiler / waterproofing contractor.

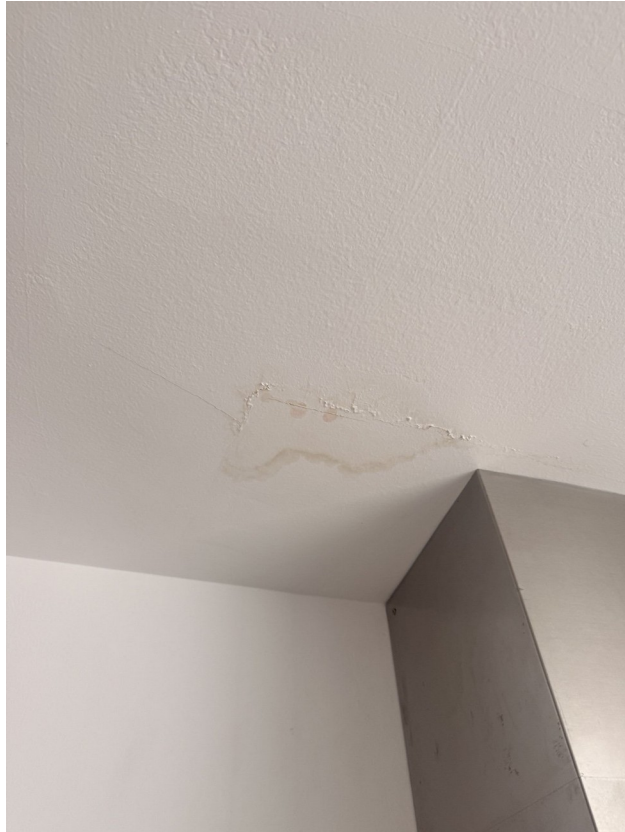
OBS-05 - Dry moisture mark at kitchen ceiling

Priority: Medium - confirmation required before purchase

Visible observation: A dry stain and localized surface damage are visible on the kitchen ceiling. No active dripping was observed during the visit.

Potential impact: The mark may be from a previous leak, roof/terrace issue, plumbing incident or condensation. Even if dry, the origin should be confirmed before relying on the repair condition.

Recommended action: Ask the seller for the origin, date and proof of repair. If no clear explanation is provided, inspect the area above and consider moisture measurement by a specialist.

Indicative cost: Approx. 550-800 EUR for localized ceiling repair and repainting after confirming no active leak.

Specialist / trade: Contractor / plumber / moisture specialist if needed.

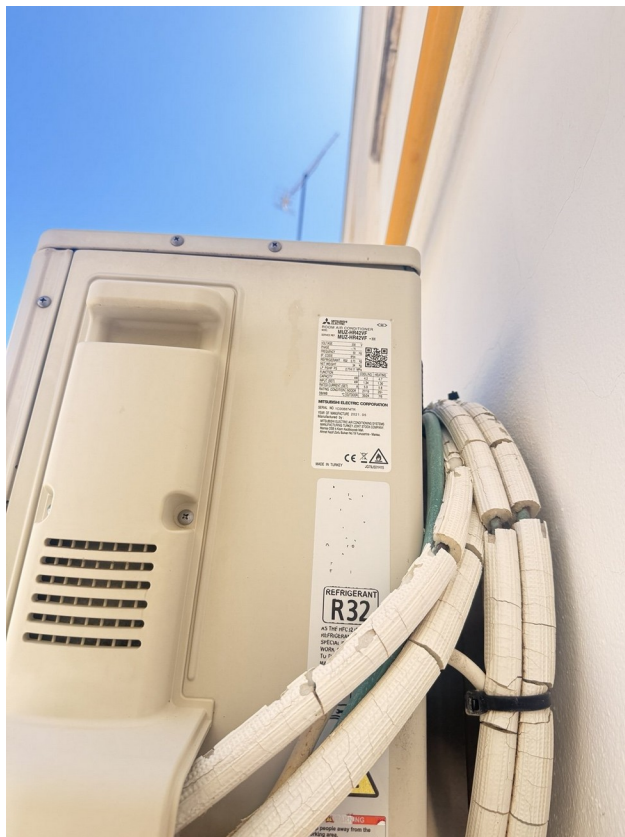
OBS-06 - Upper floor not served by air-conditioning

Priority: Medium - summer comfort and upgrade cost

Visible observation: No dedicated air-conditioning head was observed serving the upper floor. In summer conditions, cooling from the lower level should not be relied upon to cool the upper floor effectively; warm air accumulation upstairs is likely and comfort may be poor during hot periods.

Potential impact: The upper floor may be uncomfortable in July-August and for holiday rental or family use. The buyer should budget for installation of an indoor A/C head upstairs and, depending on capacity and compatibility, replacement or upgrade of the exterior condenser group.

Recommended action: Ask an HVAC technician to verify the existing system capacity, routing feasibility and electrical supply. Plan for a dedicated upper-floor A/C head and likely replacement/upgrade of the outdoor unit if the current group cannot support the additional load.

Indicative cost: Approx. 2,500-4,500 EUR for an upper-floor A/C head with exterior group replacement or upgrade, depending on routing, brand, capacity and access.

Specialist / trade: HVAC technician.

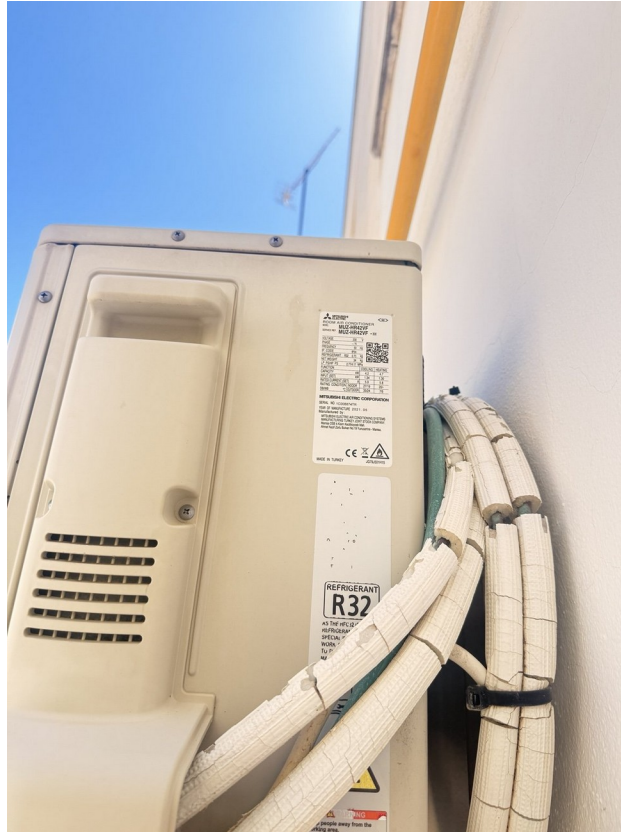
OBS-07 - Air-conditioning pipe insulation degraded

Priority: Low-Medium - efficiency and durability

Visible observation: The insulation around exterior air-conditioning lines is visibly cracked and deteriorated by sun exposure.

Potential impact: Damaged insulation can reduce thermal efficiency, increase condensation risk and accelerate deterioration of refrigerant line protection.

Recommended action: Replace the exposed pipe insulation with UV-resistant insulation and check the unit's service history and cooling performance.

Indicative cost: Approx. 150-350 EUR for insulation replacement; additional service cost if the unit requires maintenance.

Specialist / trade: HVAC technician.

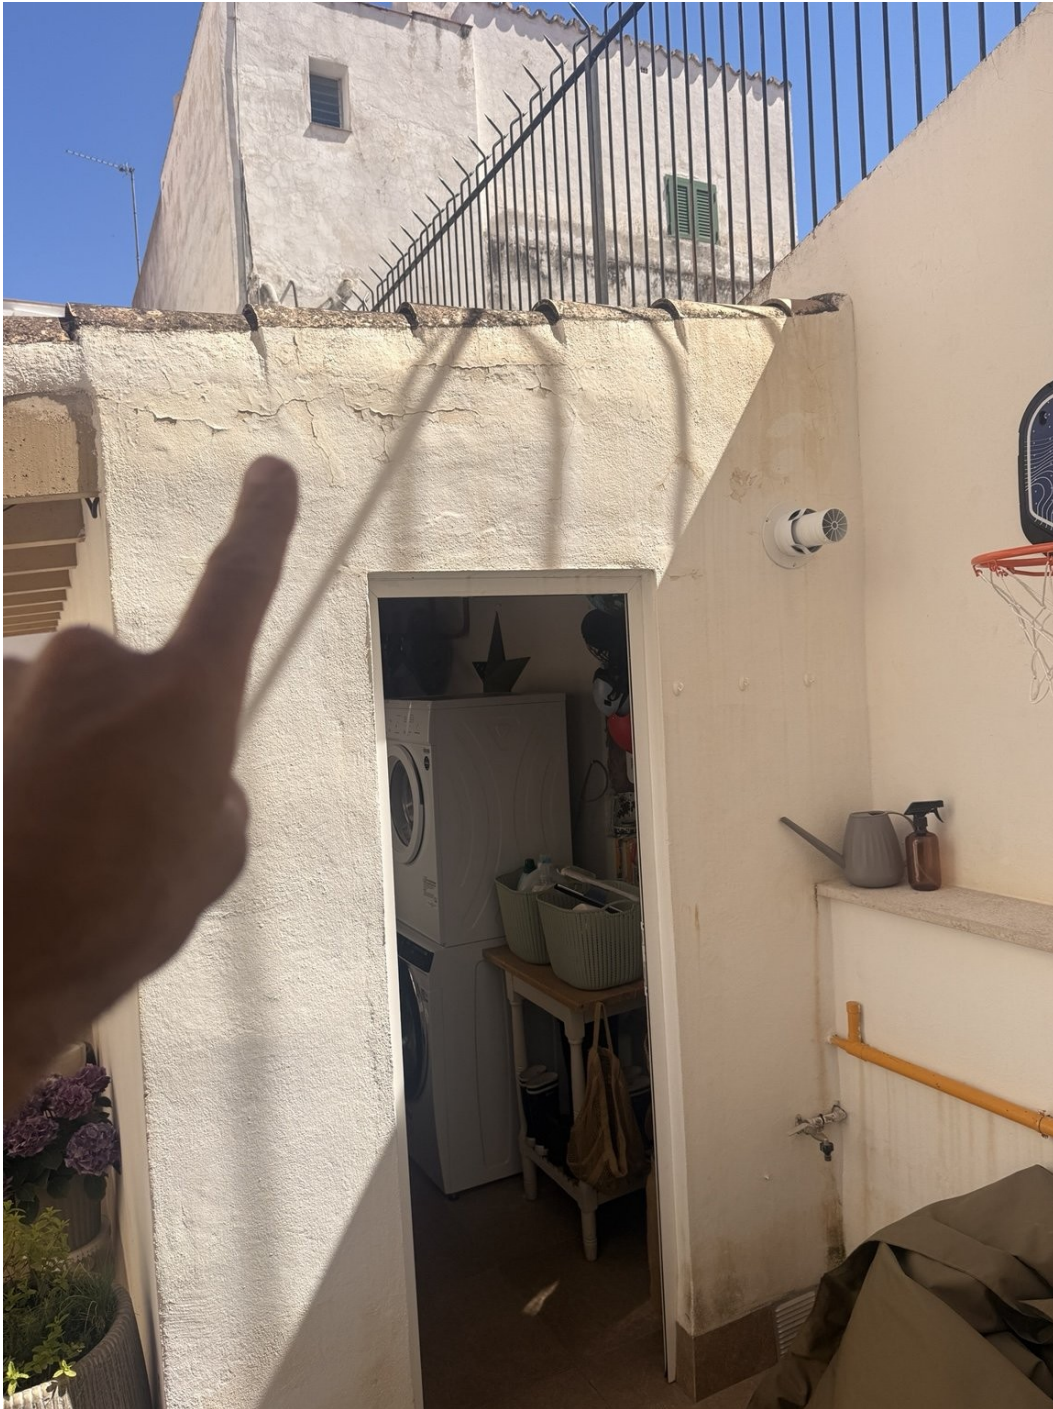
OBS-01 - Exterior utility room render cracking

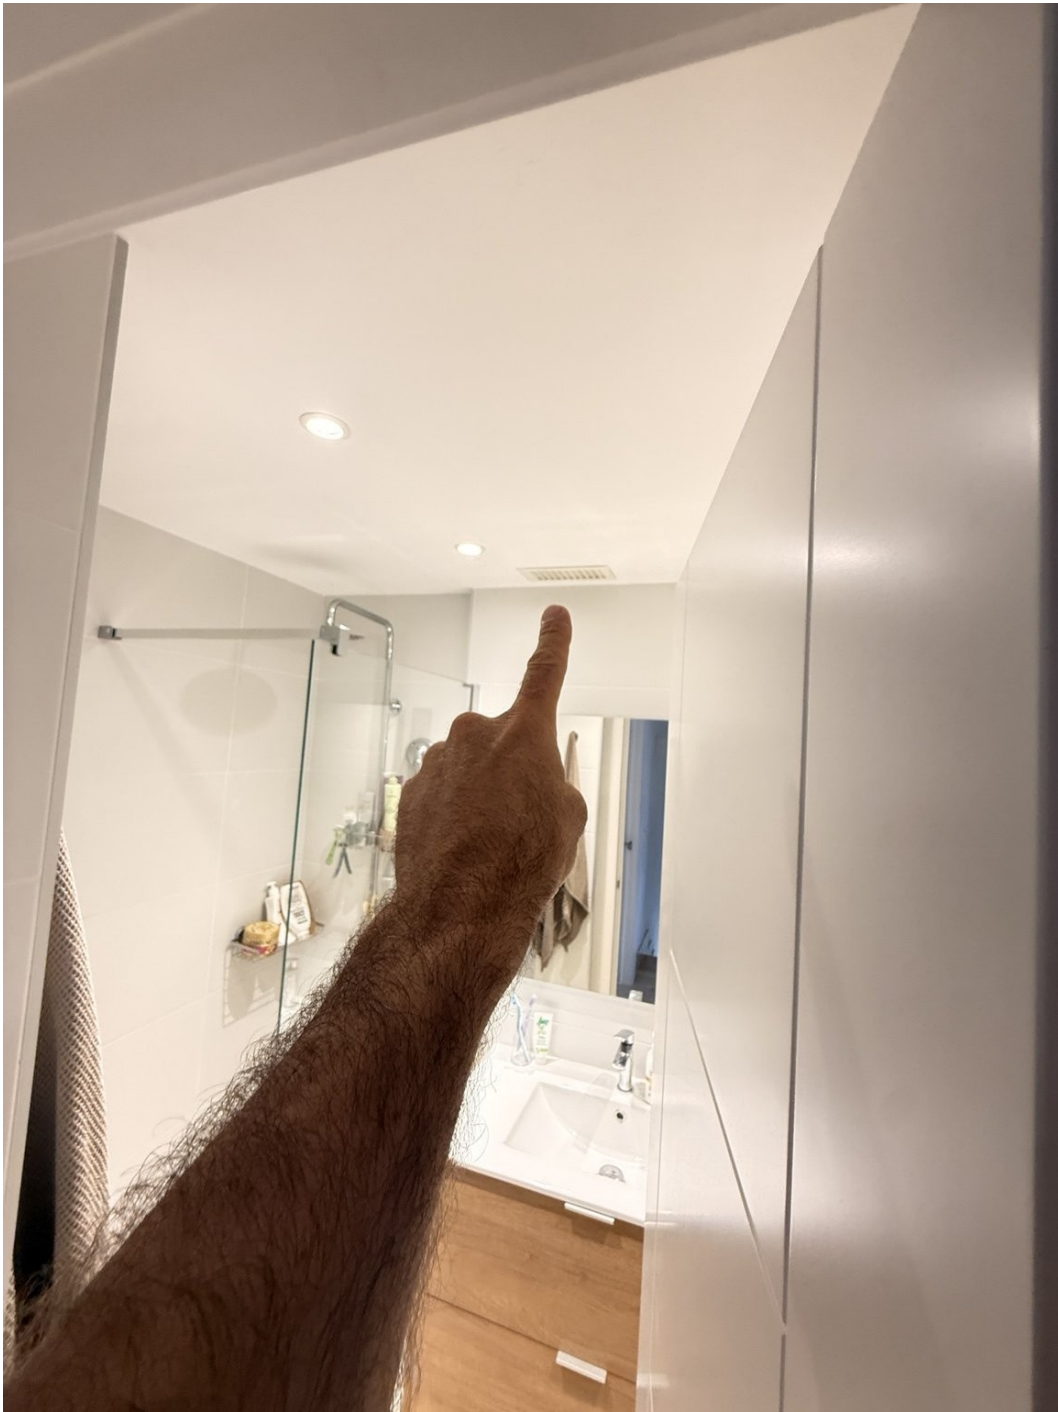
OBS-02 - Bathroom without adequate mechanical ventilation

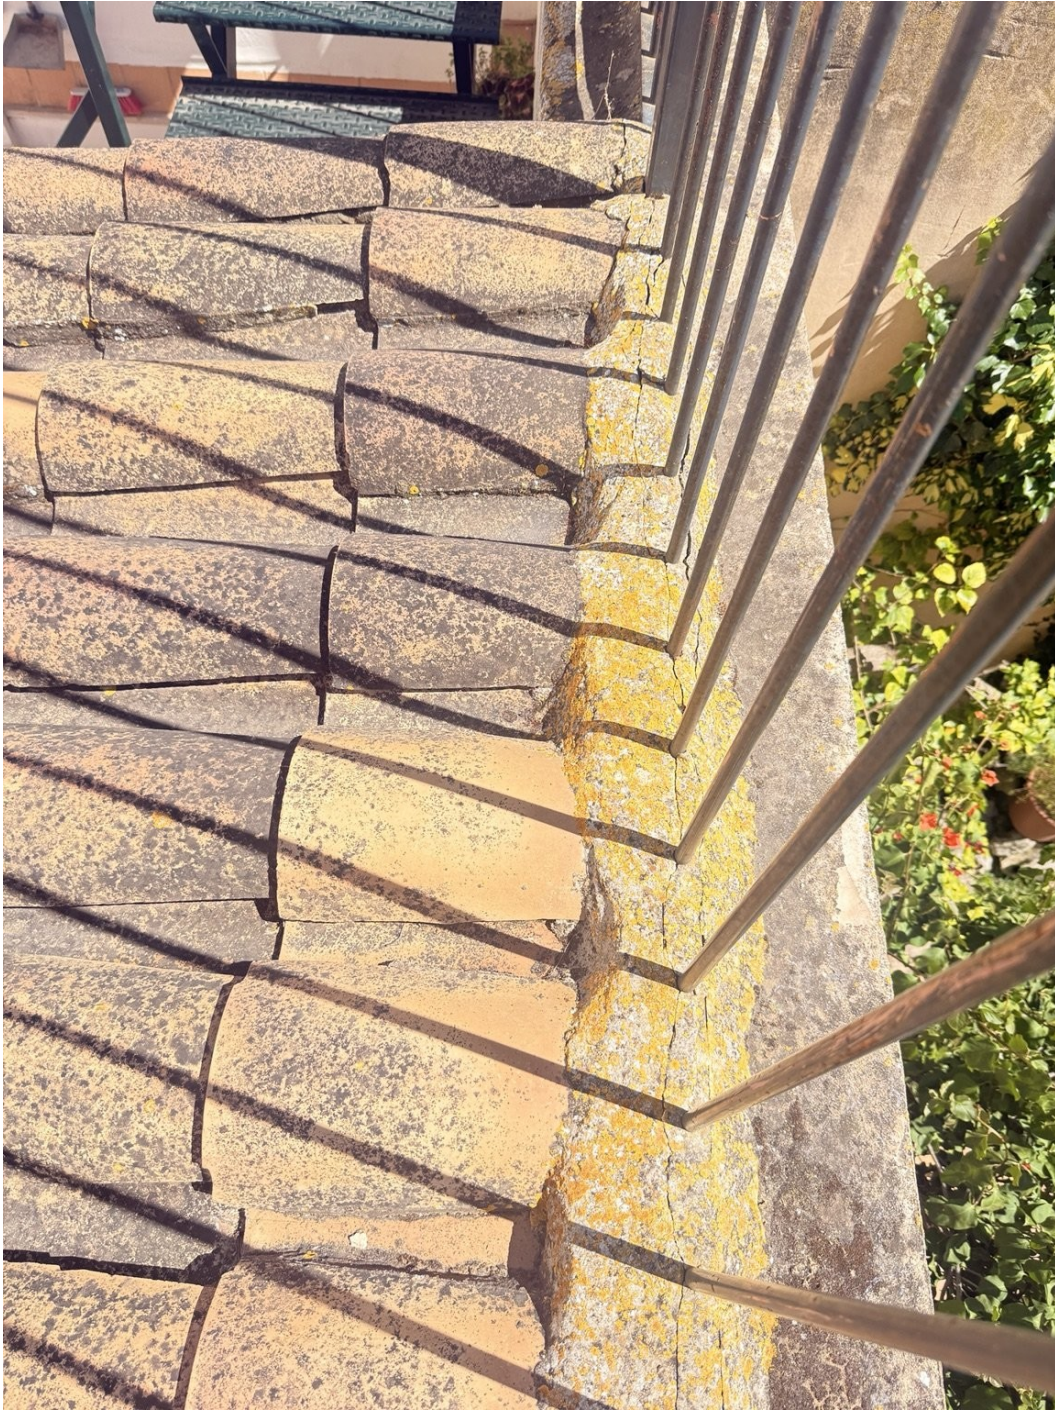
OBS-03 - Roof flashing / roof edge mortar requiring repair

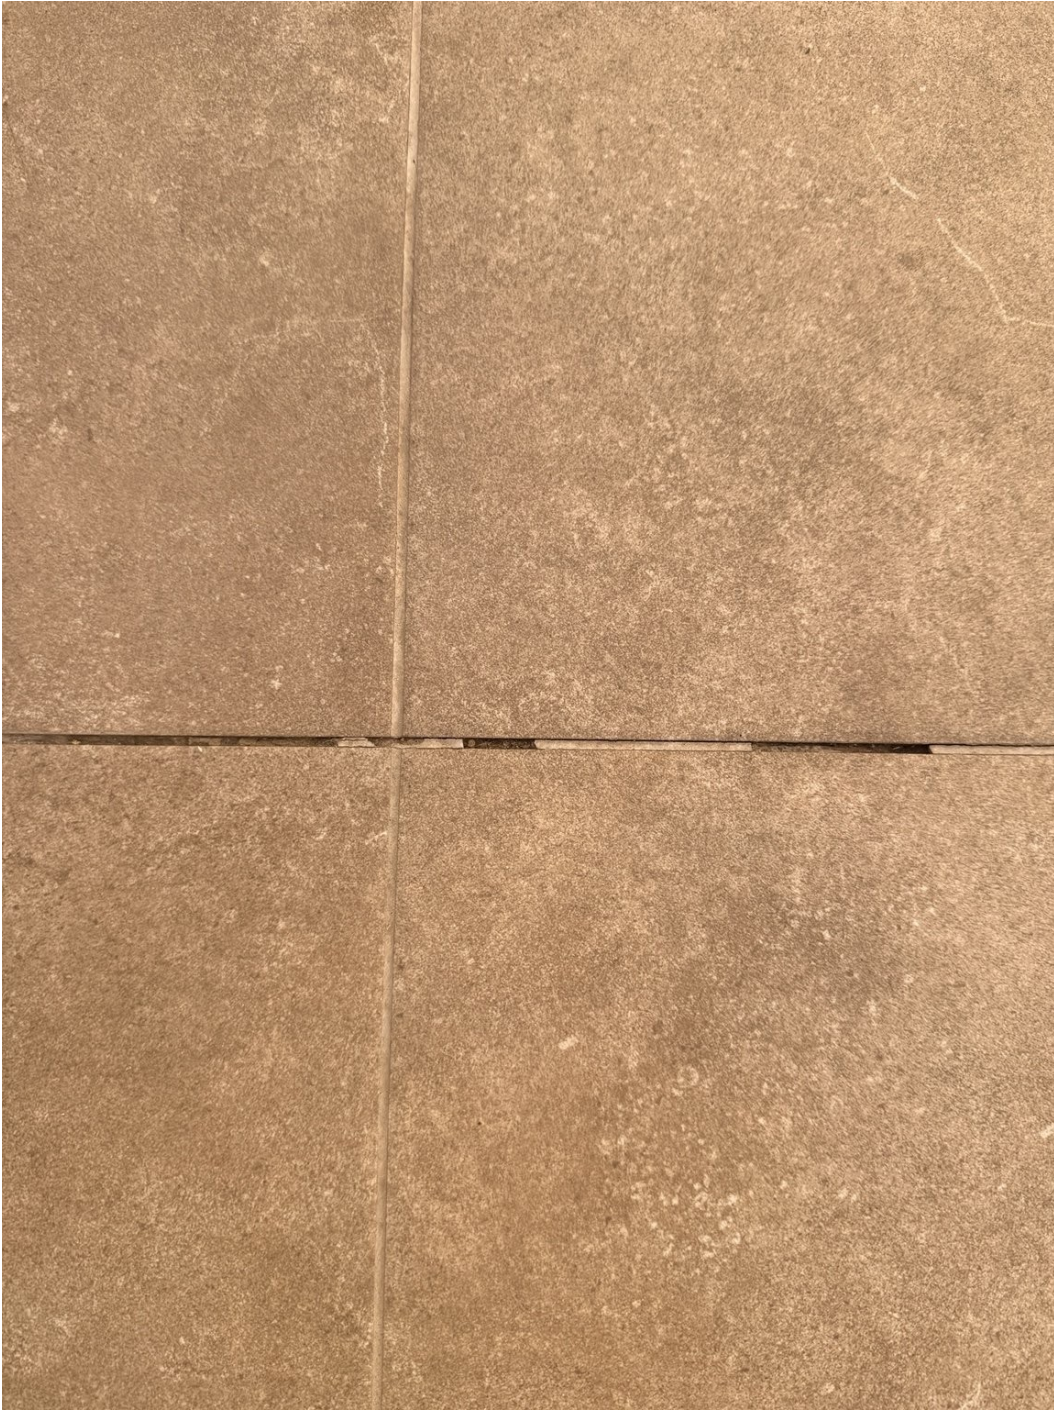
OBS-04 - Terrace tile grout joints to review

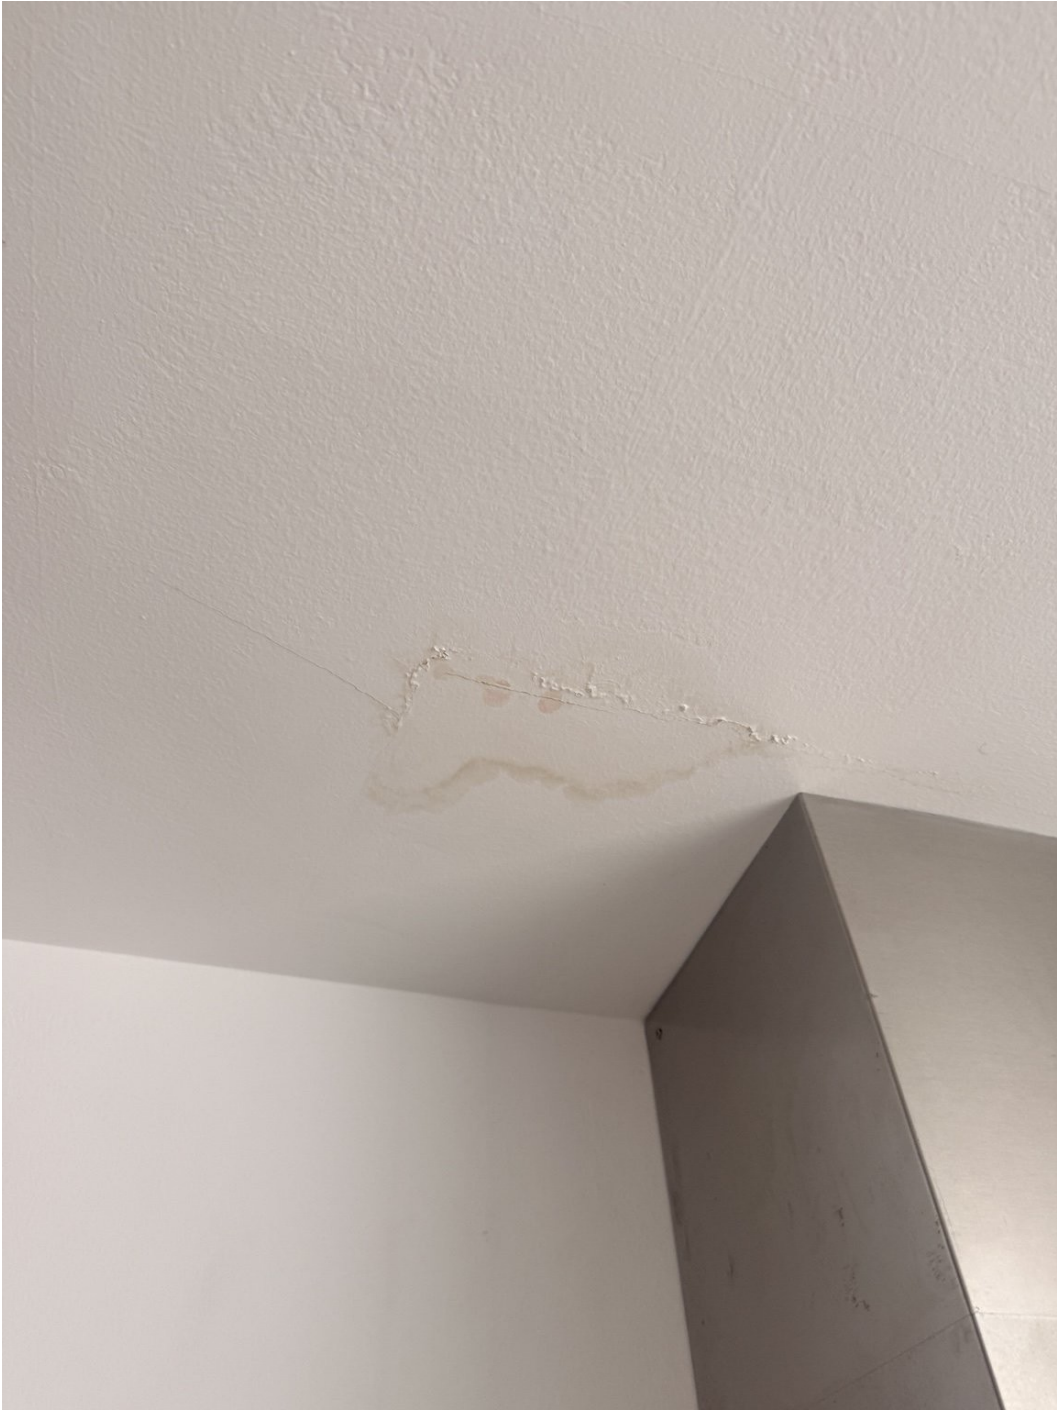
OBS-05 - Dry moisture mark at kitchen ceiling

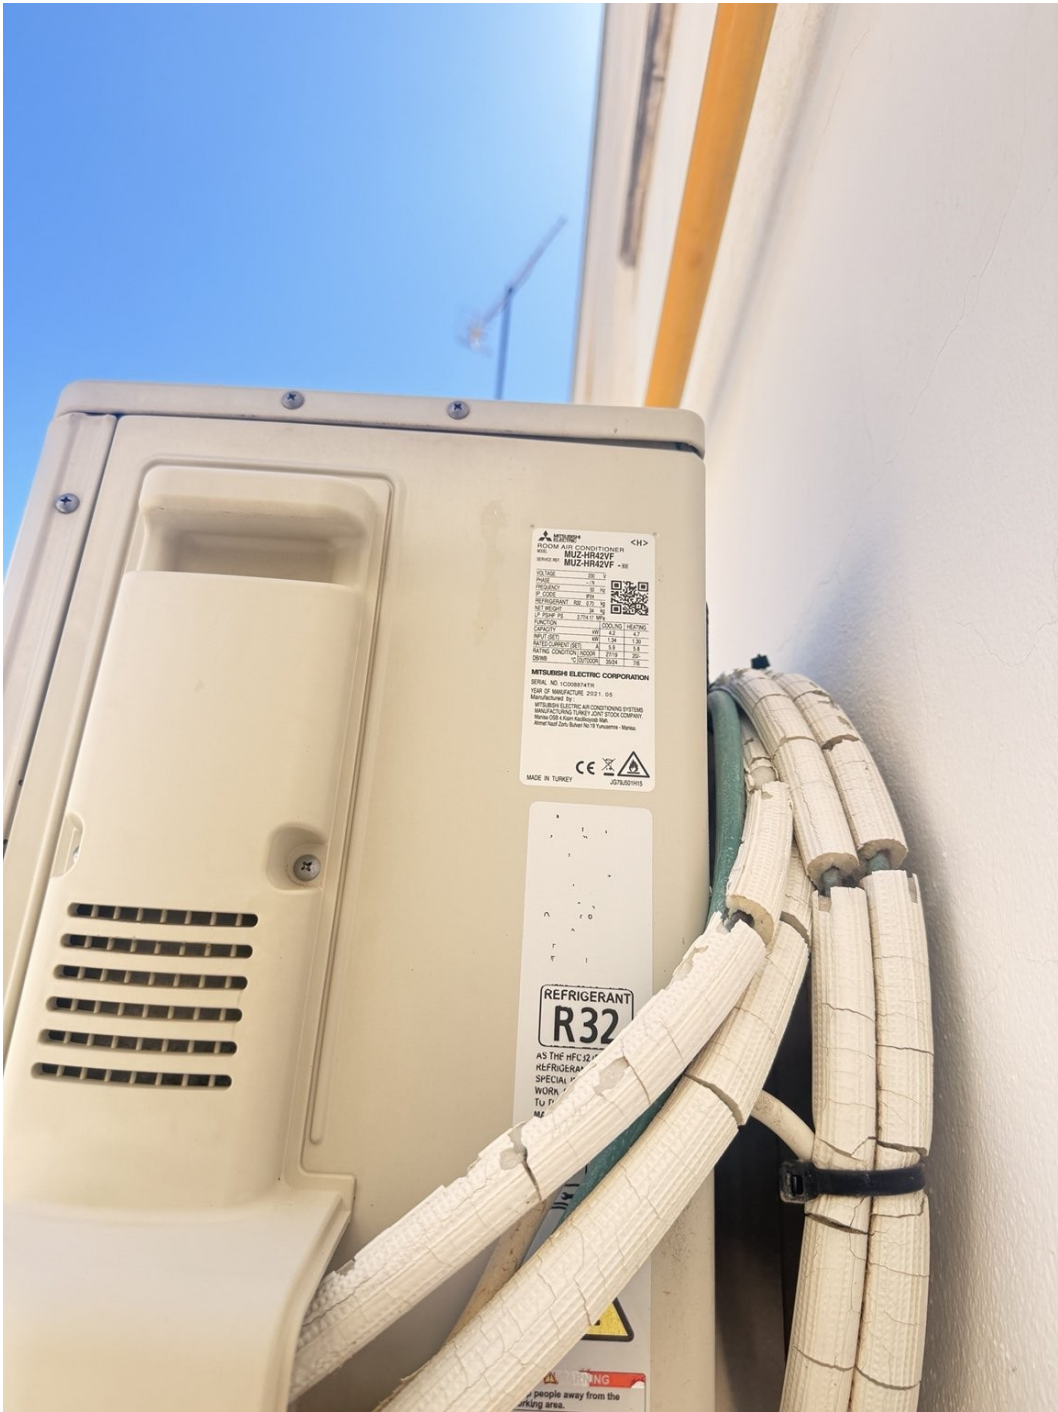
OBS-06 - Air-conditioning pipe insulation degraded

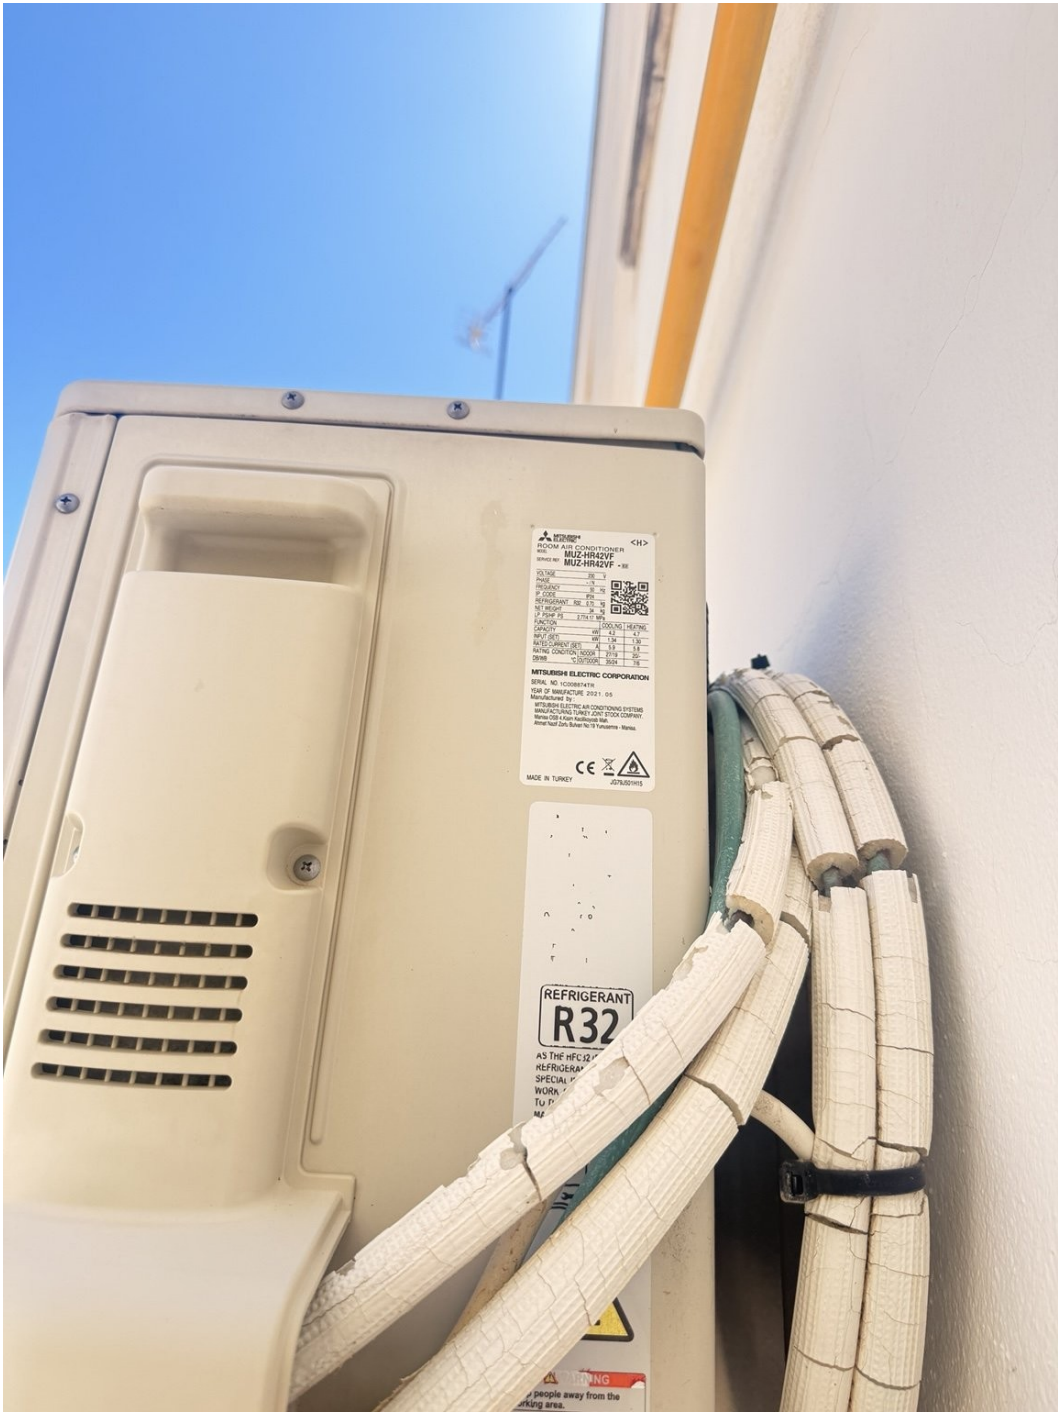
OBS-07 - Air-conditioning pipe insulation degraded / exterior group to review
